M189 cylinder liner and head gasket questions.

I am working on a 1965 W112 Coupe. The Car was missing on #3& #4 and a leakdown test indicated a leak between the two .

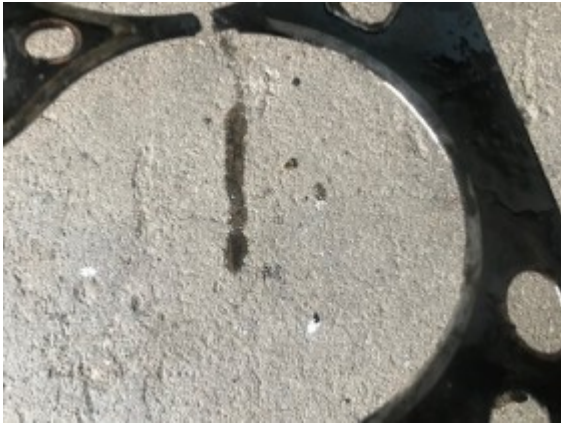
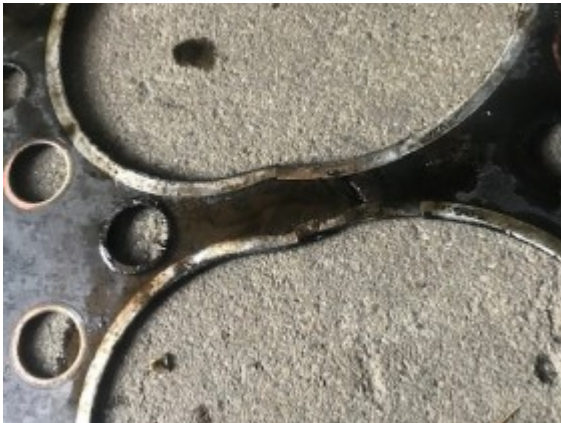
I removed the head and found the gasket blown in several places.

The cylinder head and the cylinder block appear to have "fret" marks on the surface as if the head was moving. How should I determine if the cylinder liners

A blown head gasket (if still original) is nothing unusual for that age. Check your head for linearity and/or have it milled. Then use a new OEM gasket and possibly also new head screws. Also make sure your head is matching to the engine block. The original MB repair manual might come in handy, too.

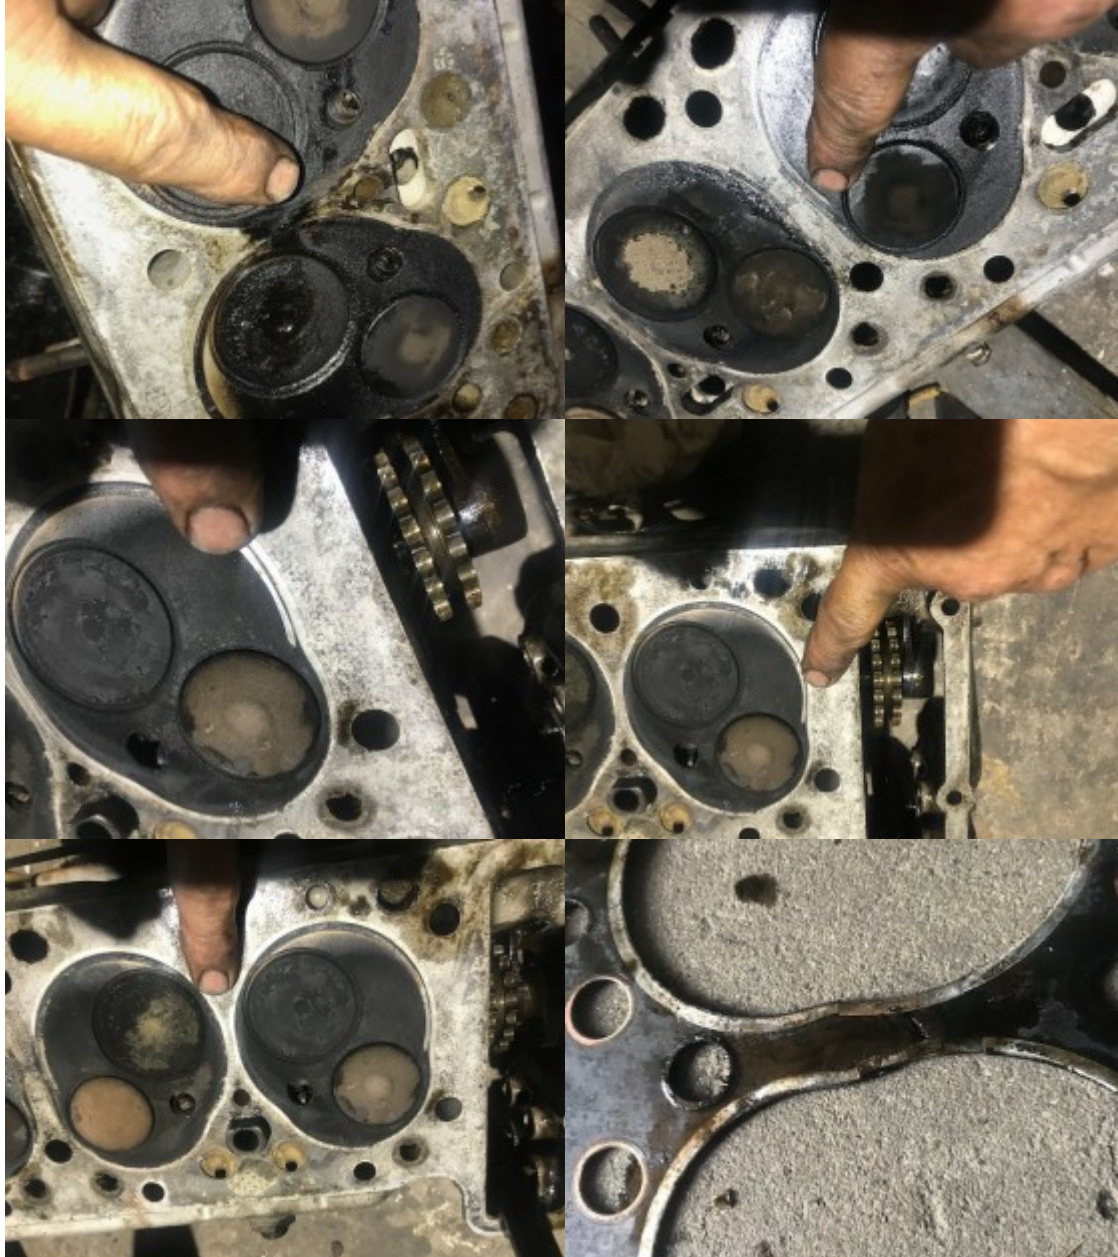
The Cylindersleeve is not in correct Position.

If that happens grind to Max. 1.5mm from Blocksurface.

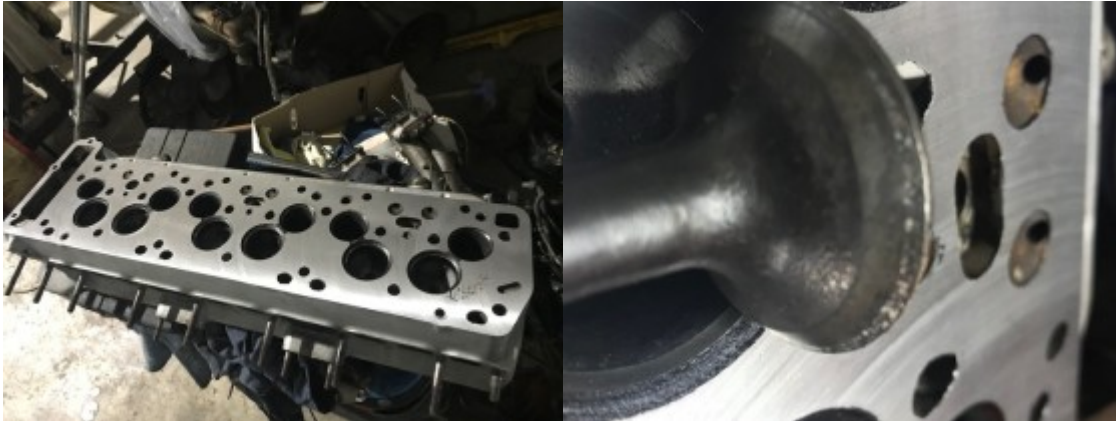
So,the machinist had my head done before lunch time but had to remove .9 which is .1 over the limit. looking at what information I have to hand I have to check the adjusting screws on the intake tappets to allow for clearance .

Anyone got any ideas about this? The head looks nice even though they couldn't get all of the marks out on # 6 combustion area. The exhaust valves show the results of leaving a car standing for 10 years...

when you take material of the head it changes the angle of the camshaft because the side where the tensioner is located is taking up the slack of the opposite side. I am not sure about the M189 but other engines have a stepped key available holding the cam shaft wheel in place to compensate for that. You get them for various angles. Check the parts catalogue of the engine, you should find them there.

If that is not available spacers under the camshaft bearings may be an option.

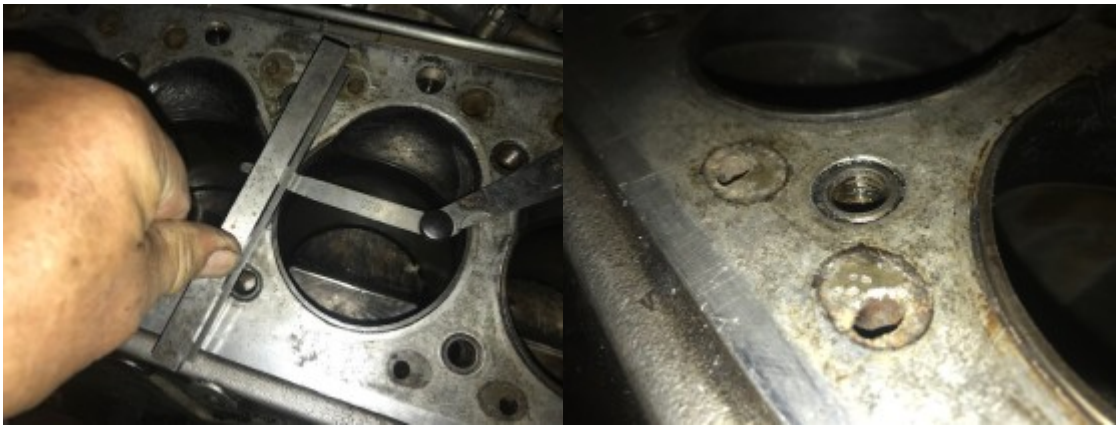
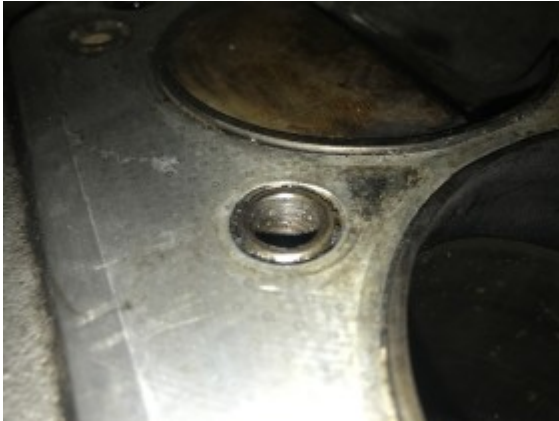
Now more mechanical horrors have raised their ugly heads. The area which had the large black burn mark in the gasket is most worrying . the liner on # 4 appears to .50 lower in that area .Possibly burnt away in the past from another gasket leak. The feeler gauge under the Straight edge is where the low spot is.

The other problems are the head bolt inserts into the alloy block. Two were not screwed in properly and sit proud of the block surface instead of below the surface. There are supposed to be self tapping and a special tool is used to screw them in . i doubt over sized ones are still available so... I might have to make a tool and use loctite to hold them n place. Assuming the threads are OK. With the head sitting so high above the block, I am surprised it hadn't blown out years ago. And thankfully it's not warped.

Hi Ron, that truly looks bad. Certainly a new gasket alone will not do the job. As far as I remember, the M189 block was made out of cast alloy, so a skilled machine shop might be able to weld on some material there, but it will require a full disassembly first...

with a reported gap of 0.5mm on the block the new head gasket won't last long. German manufacturer Elring permits 0,03mm .. 0,05 mm.

The only way to repair it here would be to replace the liner. Yes ,the m189 is an alloy block engine ,with pressed in Liners. I have a contact here in Australia who has two sets of new liners but the problem is ,I don't have the liner fitting tool or access to a oven to heat it up to 150 C so the new liners can be fitted. It's up to the owner now to decide how much his budget can be stretched ..I rebuilt another years ago and the cost was \$25,000 .
